Technical Paper: Oxistop Coatings for Boiler Tube Maintenance

EPRI: Boiler Tube & HRSG Tube Failures & Inspections International Conference

October 16-18, 2007 • Calgary, Alberta, Canada

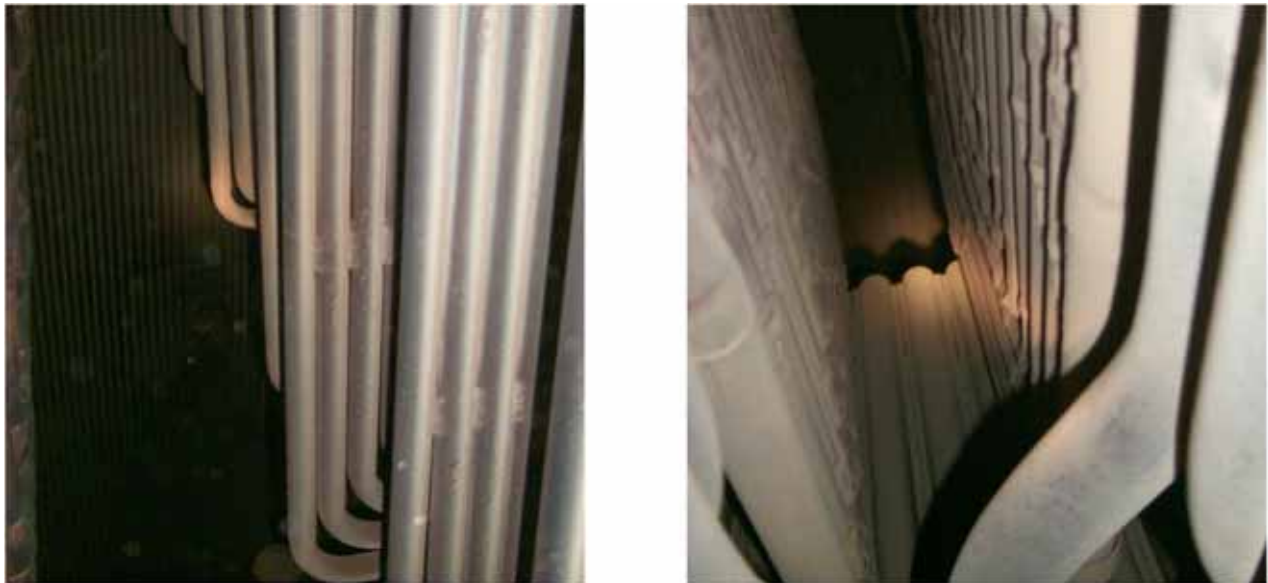
Figure 2

Primary SH Bundles and Upper Nose areas coated with Oxistop MC-19-GRP, after six months on line.

- Positive pressure cyclone fired boiler, burning eastern bituminous coal
- Eliminated slag deposits, fouling and tube wear associated with soot blowers

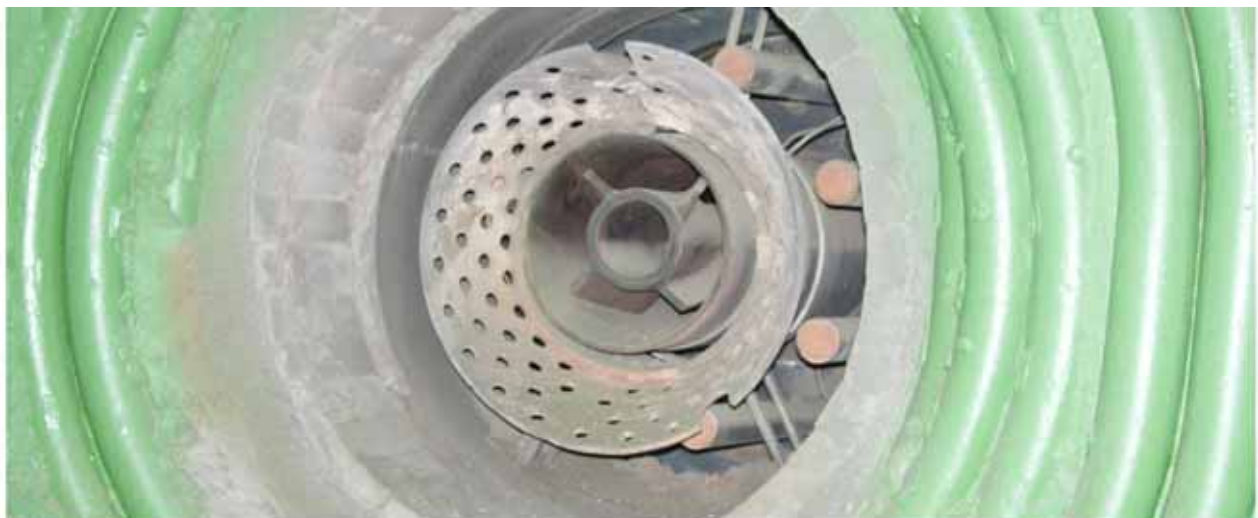
Figure 3

Based on successful trial on MC-19-GR after one year, entire burner wall coated.
Note refractory (gray) coating.

After one year of boiler operation, the coated burners developed no eyebrows and were slag free. During a planned outage in June of 2005 the coating material was found to be in-tack and continues to be in operation and performing into year three. As a result of this performance, the entire burner wall was coated (16 burners) and has continued to provide to date slag-shedding benefits, in addition to corrosion and erosion wear protection. Oxistop a GY-30 Refractory Coating was utilized to provide a slag shedding protective barrier to the burner refractory. Also coated were additional waterwall areas, for slagging and corrosion, and the underside of the upper slope to eliminate clinker buildup.

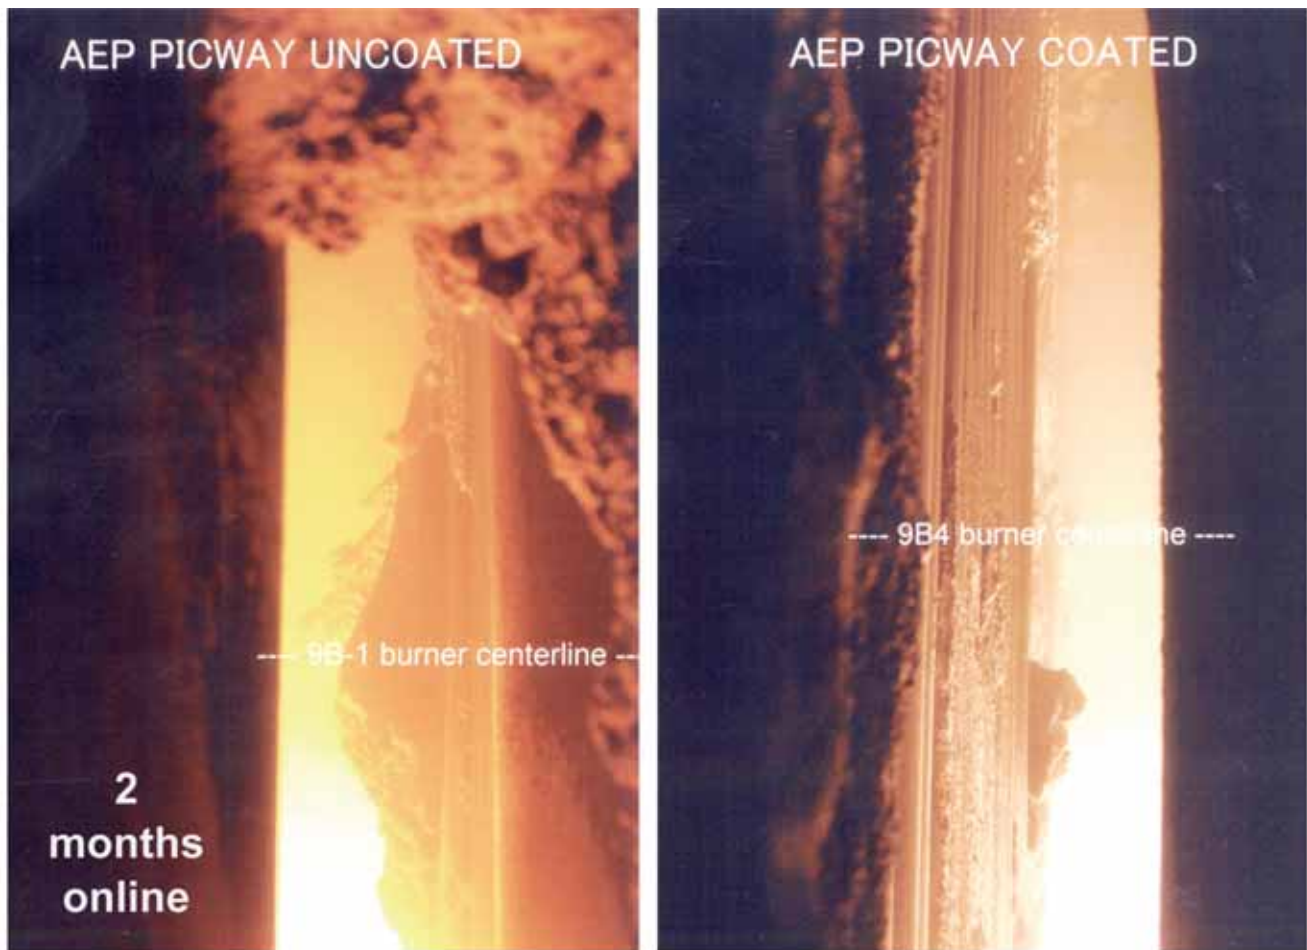
Figure 4
AEP PICWAY—2 months online, uncoated (left) and coated (right)

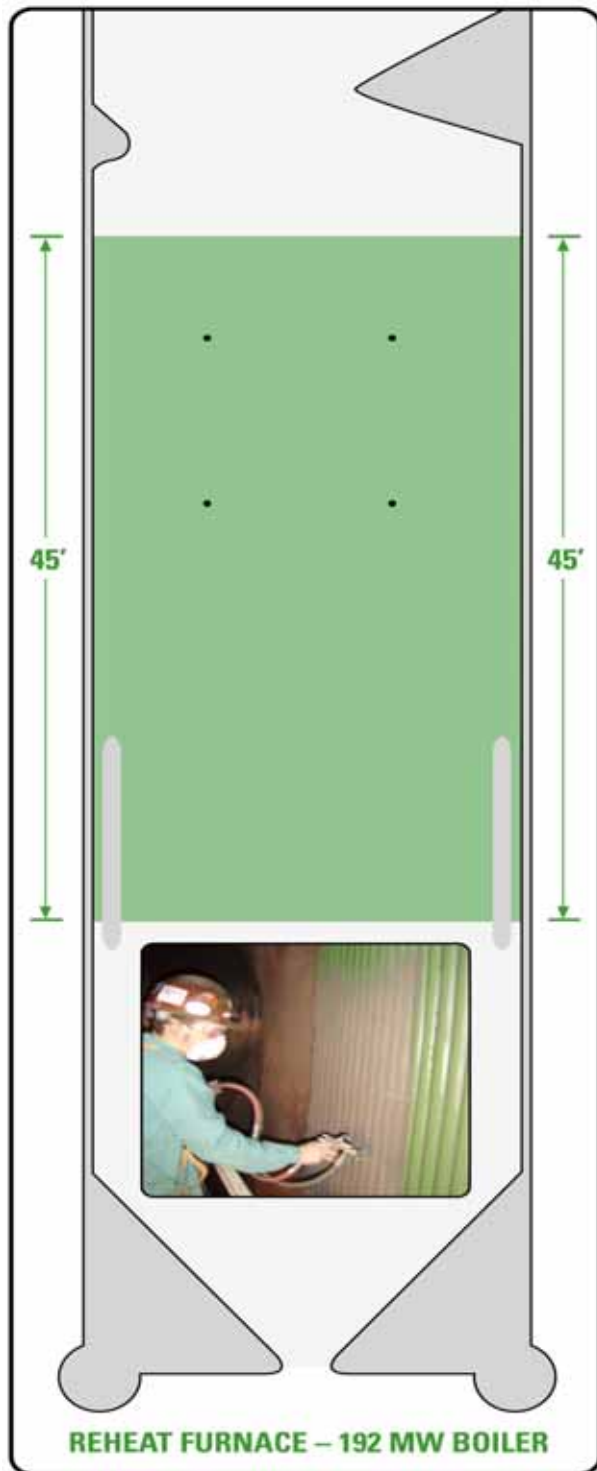
Figure 5
Slag shedding off burner wall coated with Oxistop MC-19-GR
on a 192 MW boiler burning 100% PRB coal.

- 1) The water cannon usage in this area is significantly lower.
- 2) The cordial thermocouple rate of delta-t is notably slower and, more significantly, stabilizes at a lower number.
- 3) The furnace exit gas temperatures (FEGT) of the reheat box are below historical data.
- 4) High temp RH and low temp SH thermocouples are below historical data.
- 5) Decrease in air heater outlet gas temperature.
- 6) Lower fuel usage eliminating over firing to make steaming rate.
- 7) Maximum megawatt output is increased to 198 Megawatts, with slightly less coal burned.

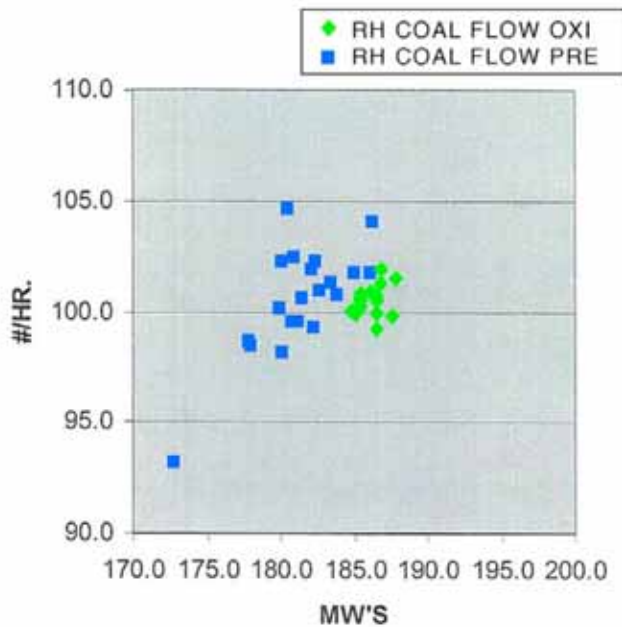
Figure 6

For the same reheat furnace coal flow, there is approximately a 5 to 7 MW increase in total output. This increased output could be argued to have come from higher BTU fuel. Subsequent graphs will confirm that the improvements in load are attributed to increased waterwall absorption.

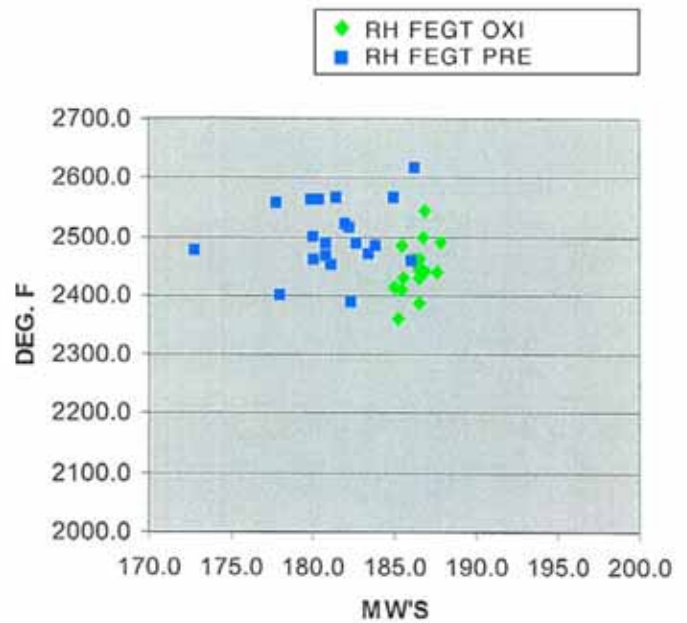
Figure 7

The 75° drop in reheat furnace exit gas temperature (FEGT) for the same furnace heat input implies that more heat is being absorbed in the furnace itself.

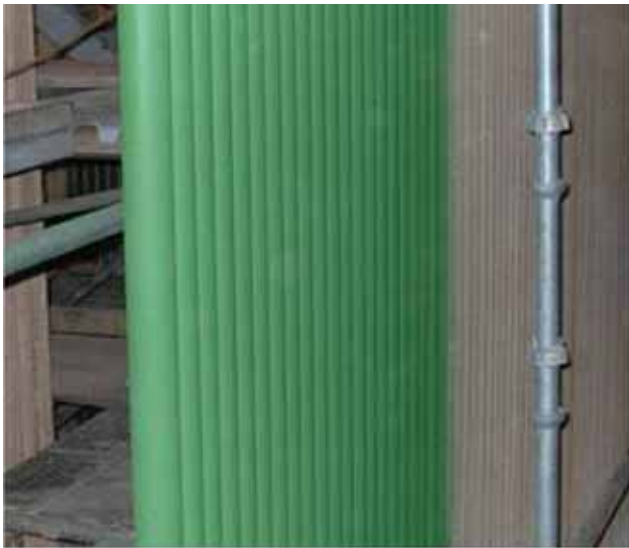
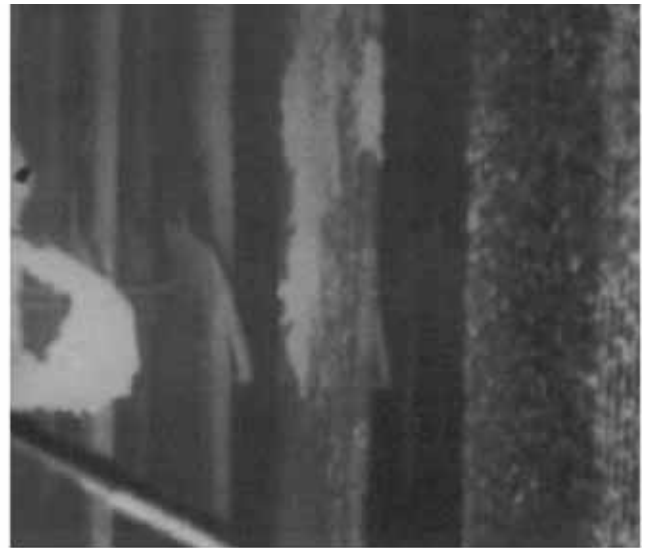
Figure 8
 (left) Division Wall Panel coated with Oxistop MC-19-GRP. (right) ONLINE INFRARED IMAGE OF THE COATED AREAS—2.5 YEARS ONLINE(taken approx 6 months ago)
